Improving Flood Diversion Soil bunds

From Africa to Asia and Back Again

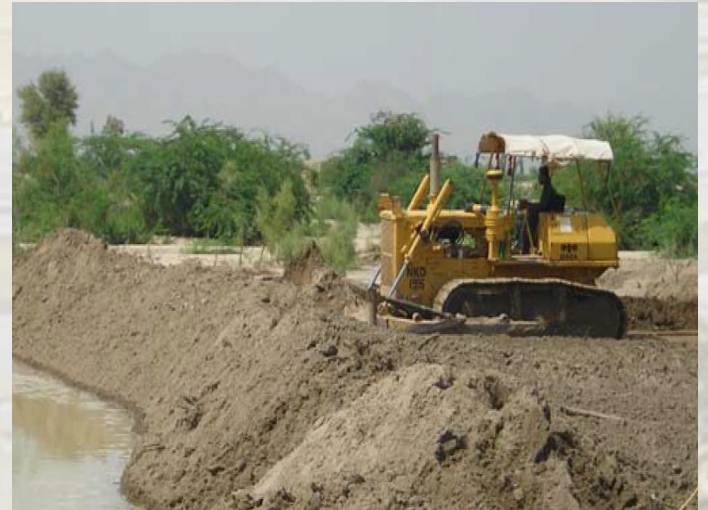
Example Pakistan: Use of Porous stone spillways with earthen bunds (1)

- Pioneered in 10 000 ha FBFS in Dera Ismail Khan Command area of Daraban in Pakistan (building on a long tradition of earthen guide bunds)
- The porous stone spillway allows slow, continuous seepage preventing upstream floodwater pressure build-up thus protecting the earthen bund from destruction
- In Pakistan and Yemen have successfully reduced the frequency of failure of earthen diversion bunds.

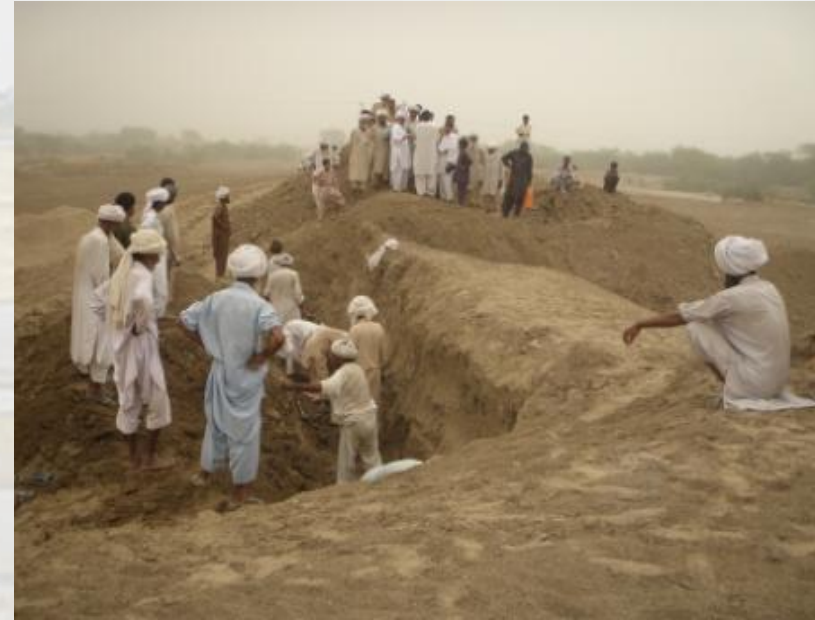
Example Pakistan: Use of Porous stone spillways with earthen bunds (2)

- Increased the opportunity for irrigation, minimized the damage to irrigable land and ultimately contributed to higher agricultural production.
- The initial investment is estimated at 100 USD per ha, which is about 4% that of the modern headworks

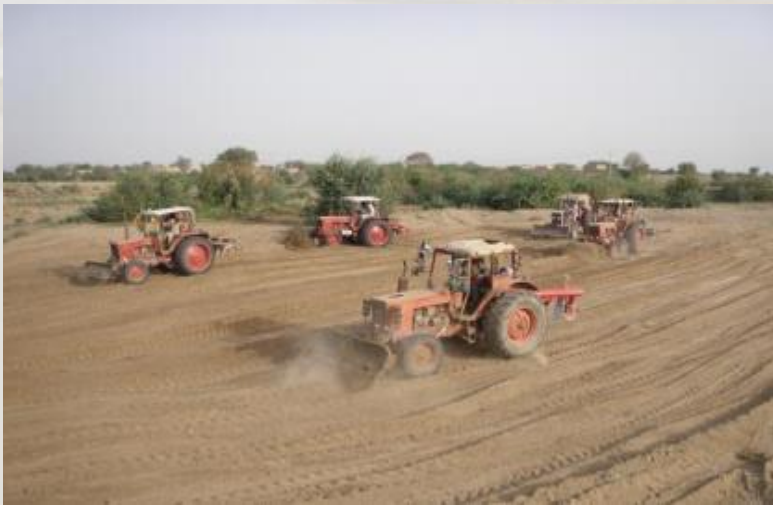
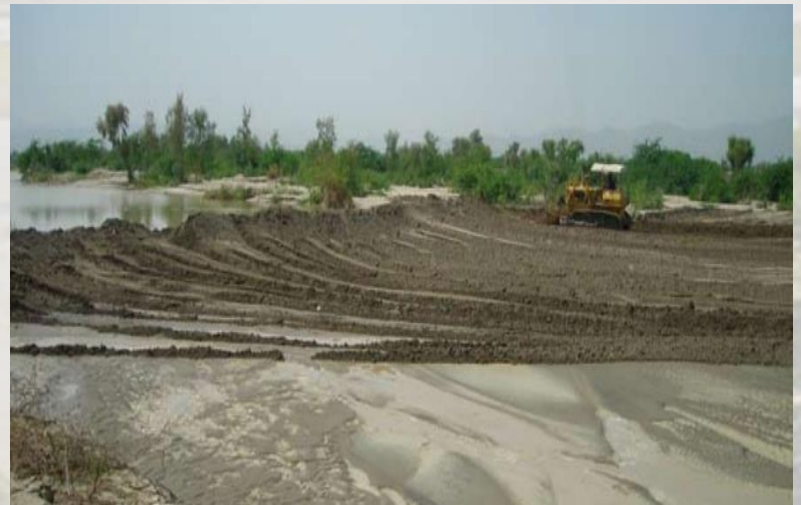
Use of Machinery

- Increase availability of earth moving equipment
- Better services through trained bull dozer operators
- Overall investments in durability of the soil bund systems
